# The Cruising Club of America

## REPORT OF THE YACHT-TO-YACHT CREW RESCUE REVIEW TEAM

OCTOBER 2026

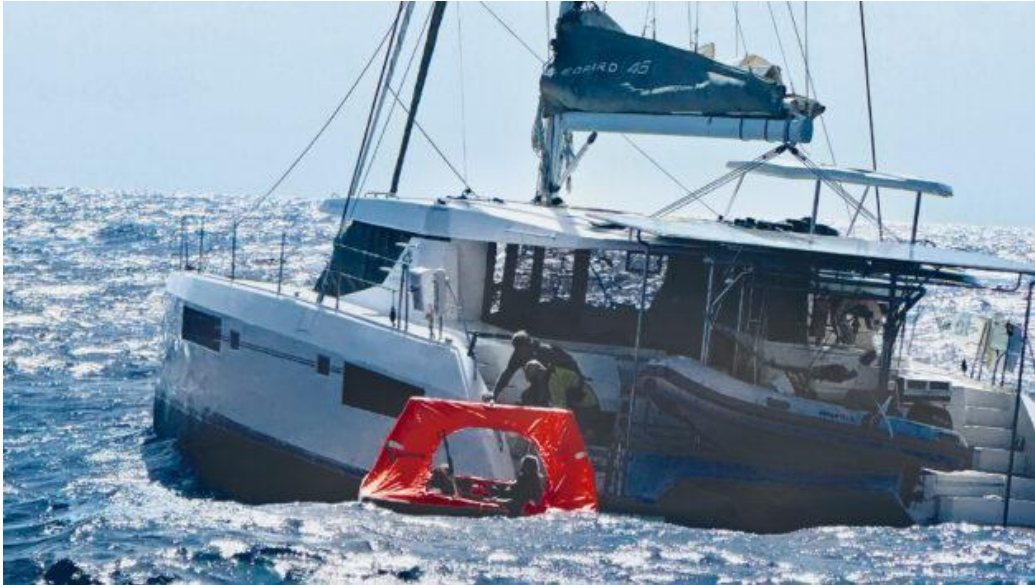
Crew of the Leopard 45 Karolina Viking climb aboard their life raft after water ingress flooded an engine room. (Cinderella di Sanremo)

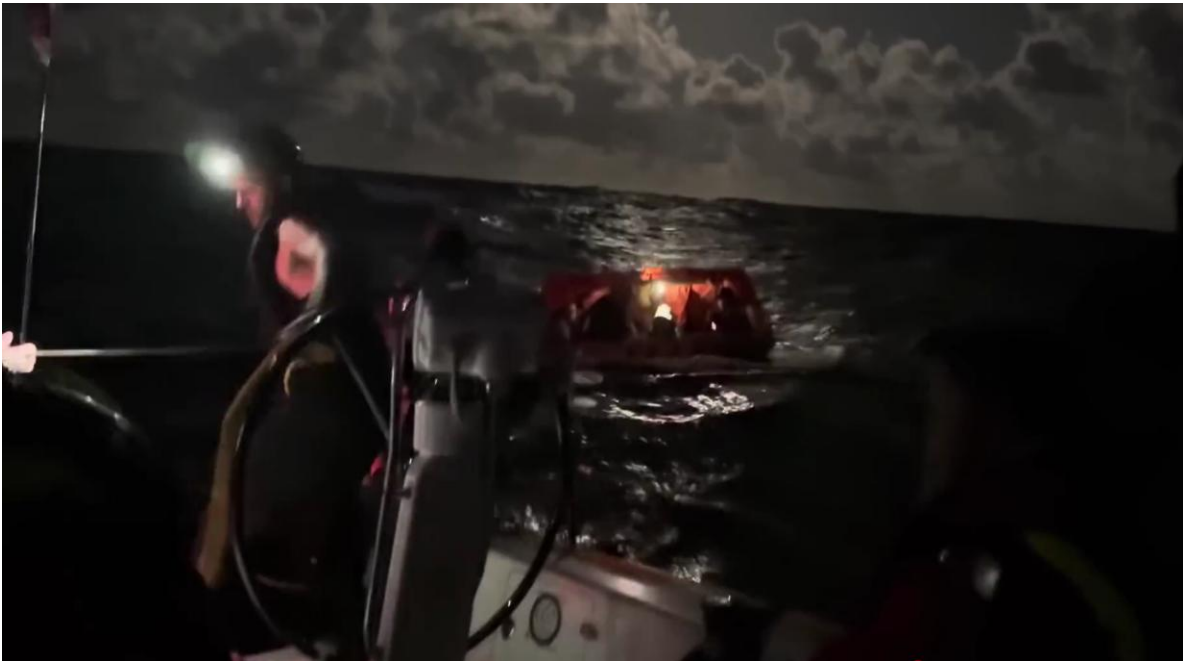
*In the 2024 Newport Bermuda Race, the crew of VID Alliance transferred to RV Ceilidh via the transom platform. Due to the sea state, it required help from two strong crew members from Ceilidh to hold the raft and grab the Alliance crew one at a time when the waves were right. During the transfer the upper tube on the life raft was punctured, most likely by the swim ladder on Ceilidh's transom.*

The life raft and crew of S/V Alliance at RV Ceilidh's stern (Ryan Mann)

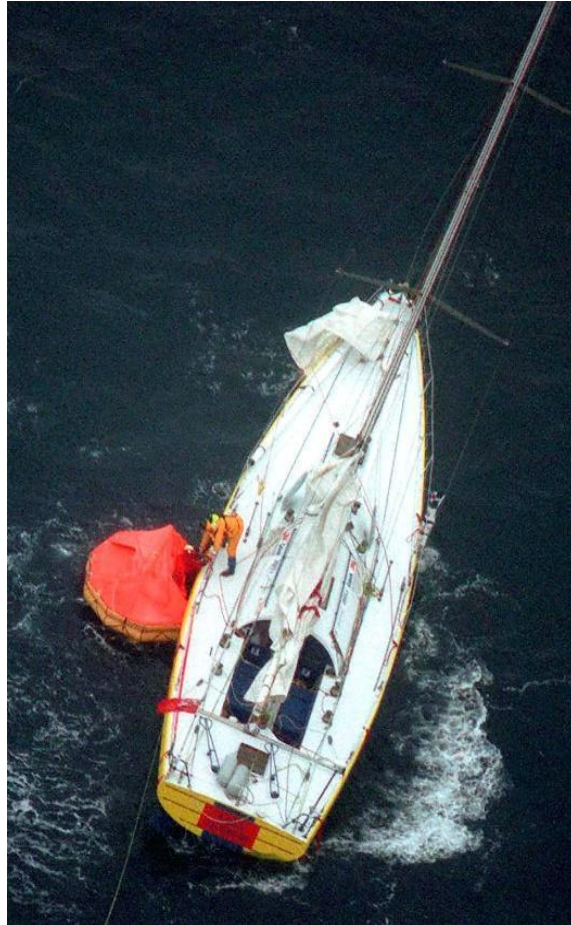
Peter Goss on RV Aqua Quorum rescues Raphaël Dinelli from VID Algimouss in the Southern Ocean.  
(RAAF)

*Aqua Quorum's 1996 rescue of Raphaël Dinelli on VID Algimouss is recognized as one of the most demanding rescues in the Southern Ocean; sailing upwind in a gale was the first accomplishment! Peter Goss on Aqua Quorum suggests that without the help of the RAAF aircraft he probably have never been able to find the life raft in the sea conditions. In preparation, personal safety tether lines were arranged along the deck edge before the final approach so they could very quickly be clipped onto the life raft, enabling a physical connection as soon as the RV & life raft were alongside. A long line was towed behind the RV with fenders attached as an extra option for Dinelli to grab hold of if the RV sailed past.*
